Demolition of the Fixed Service Structure FSS and Rotating Service Structure RSS, Launch Complex 39B at the John F. Kennedy Space Center, Florida.

**LIMITED ASBESTOS INSPECTION  
FOR THE  
DEMOLITION OF LAUNCH COMPLEX PAD 39B  
AT  
JOHN F. KENNEDY SPACE CENTER, FLORIDA**

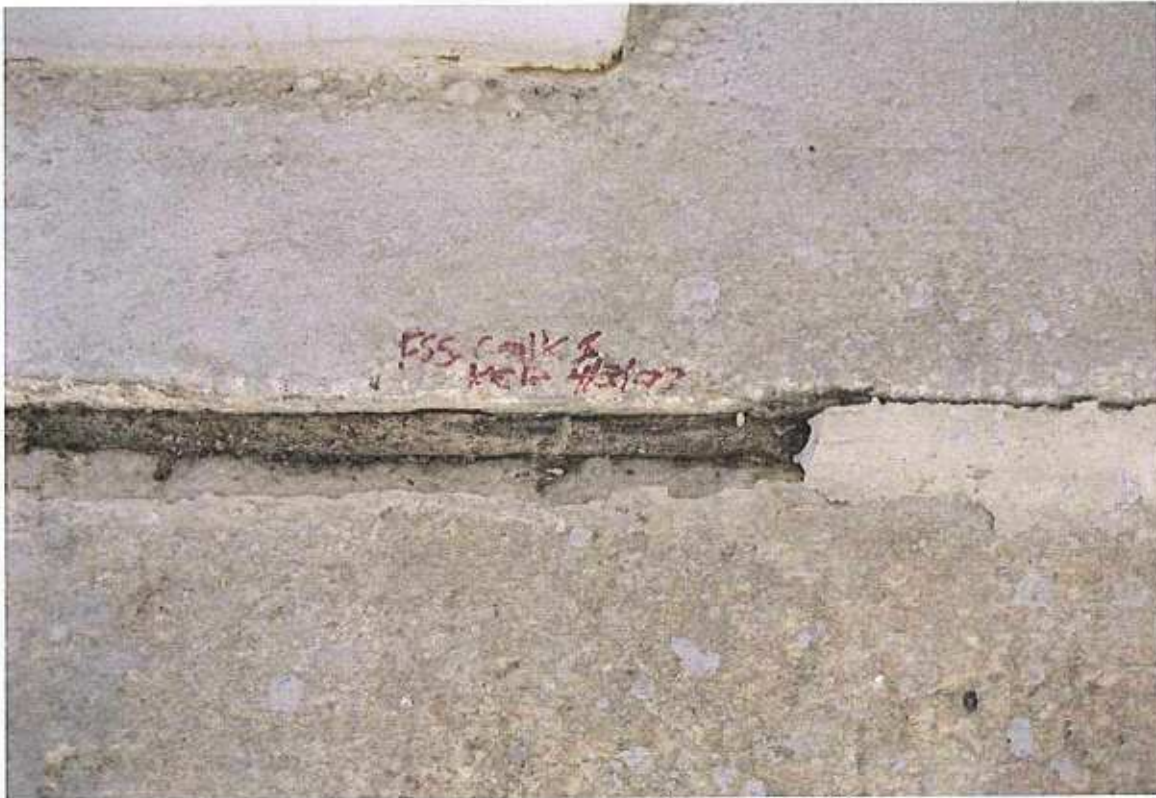
Photo 1 - Caulk on Pad Surface under FSS

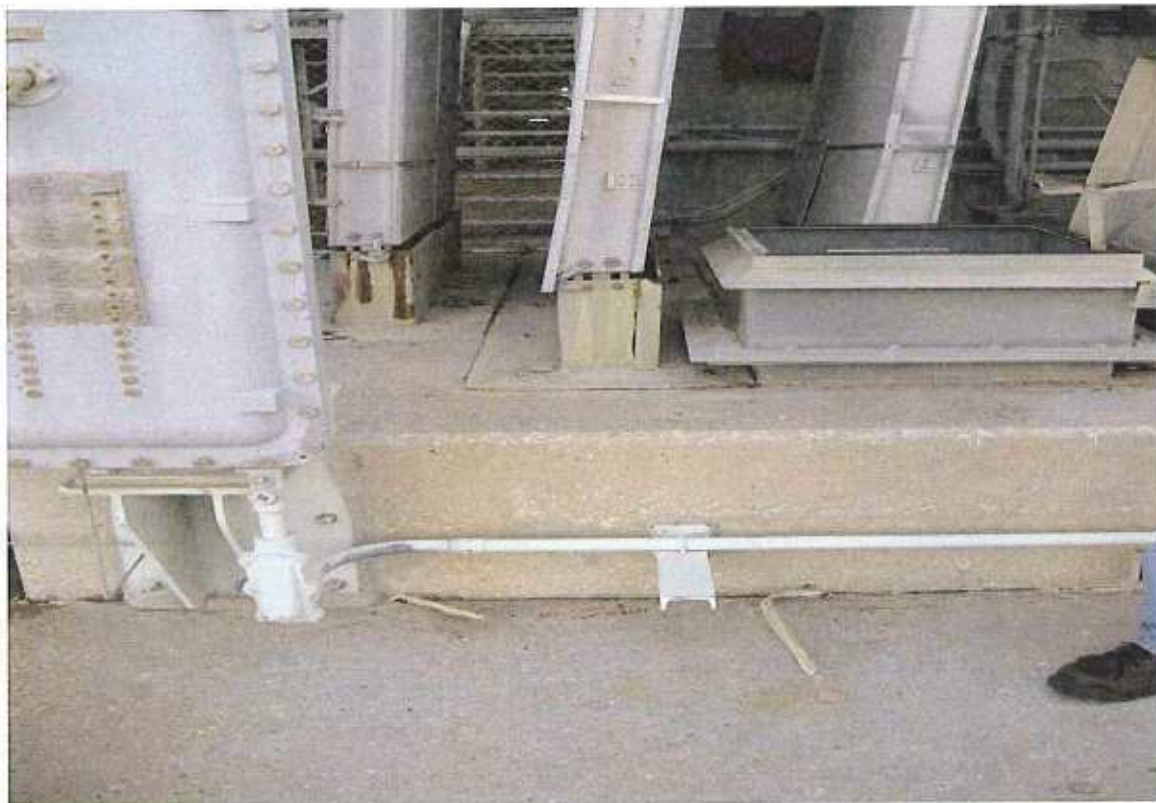
Photo 2 - Caulk on Pad Surface under FSS

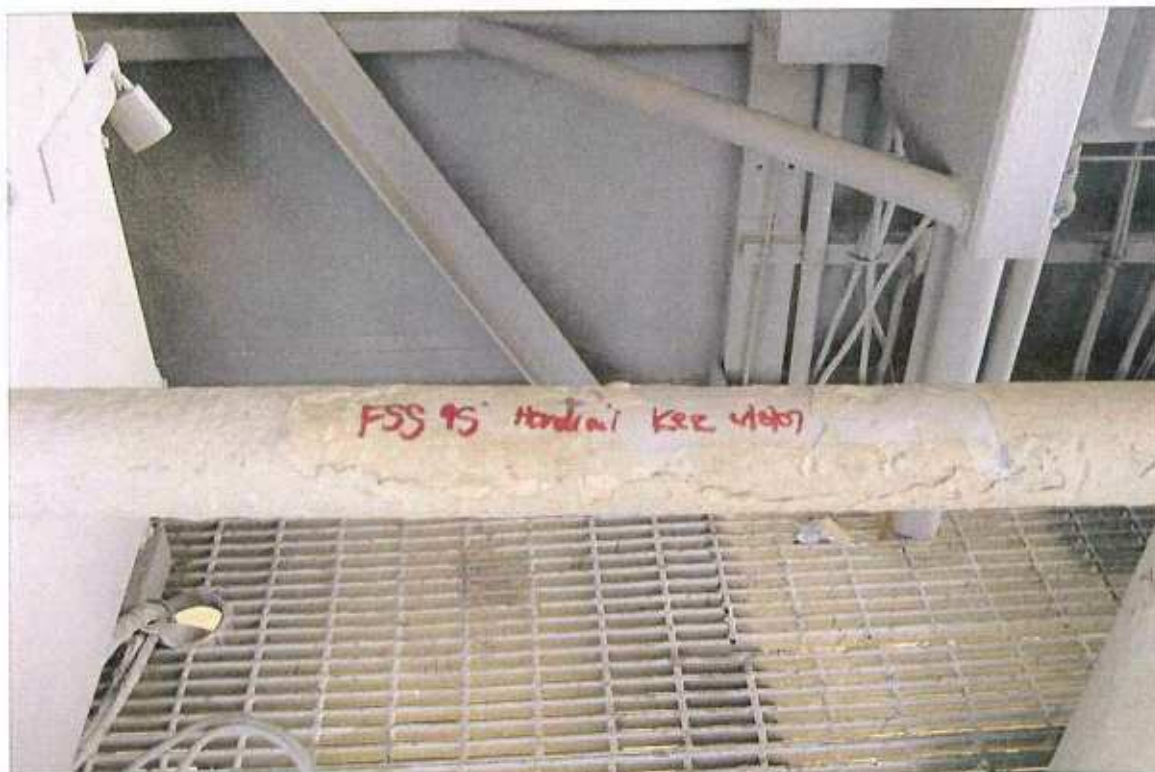
Photo 3 - Handrail at FSS Level 95

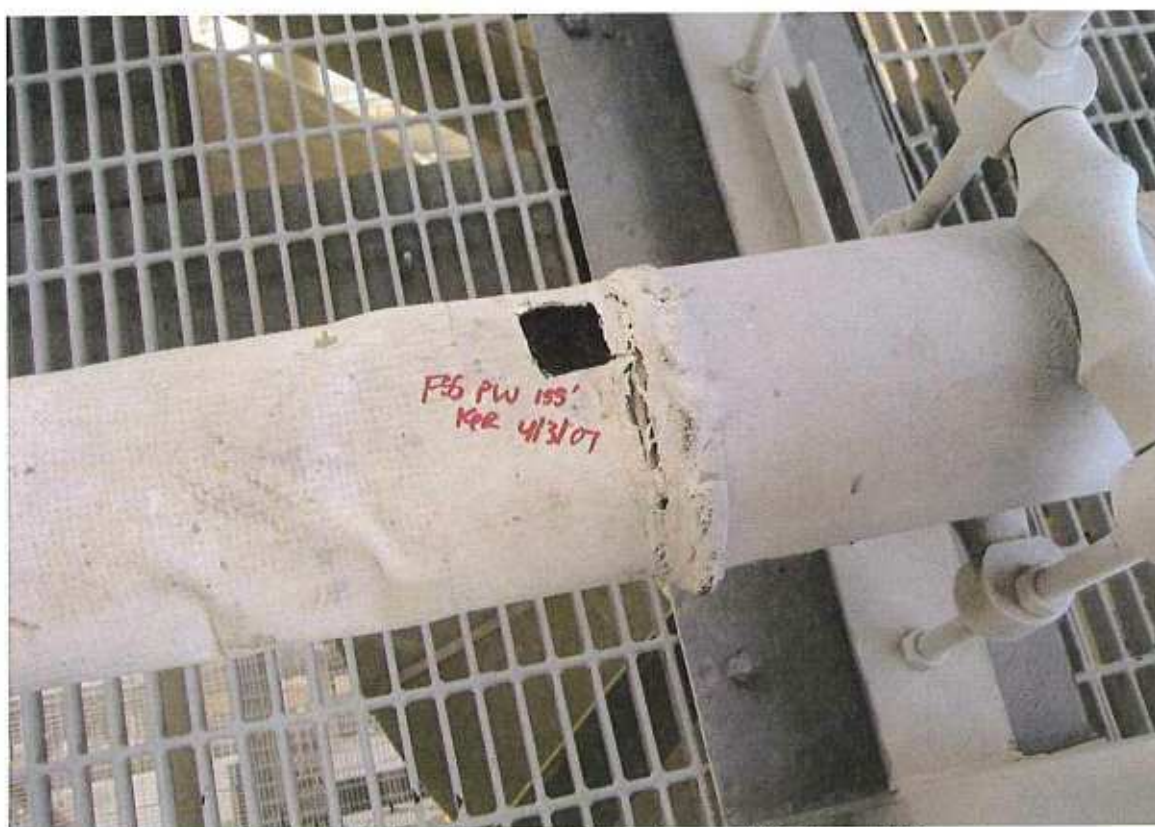
Photo 4 - Pipe Wrap and Insulation at FSS Level 155

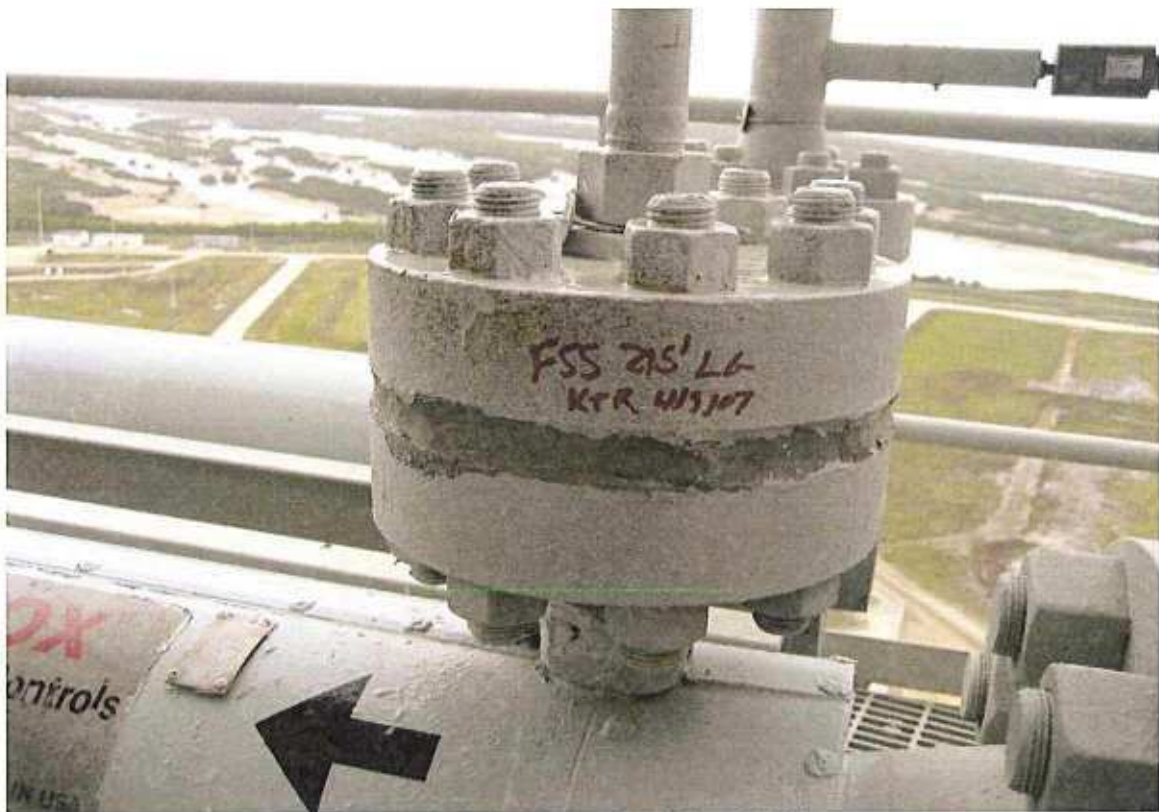
Photo 5 - Gasket on FSS Level 215

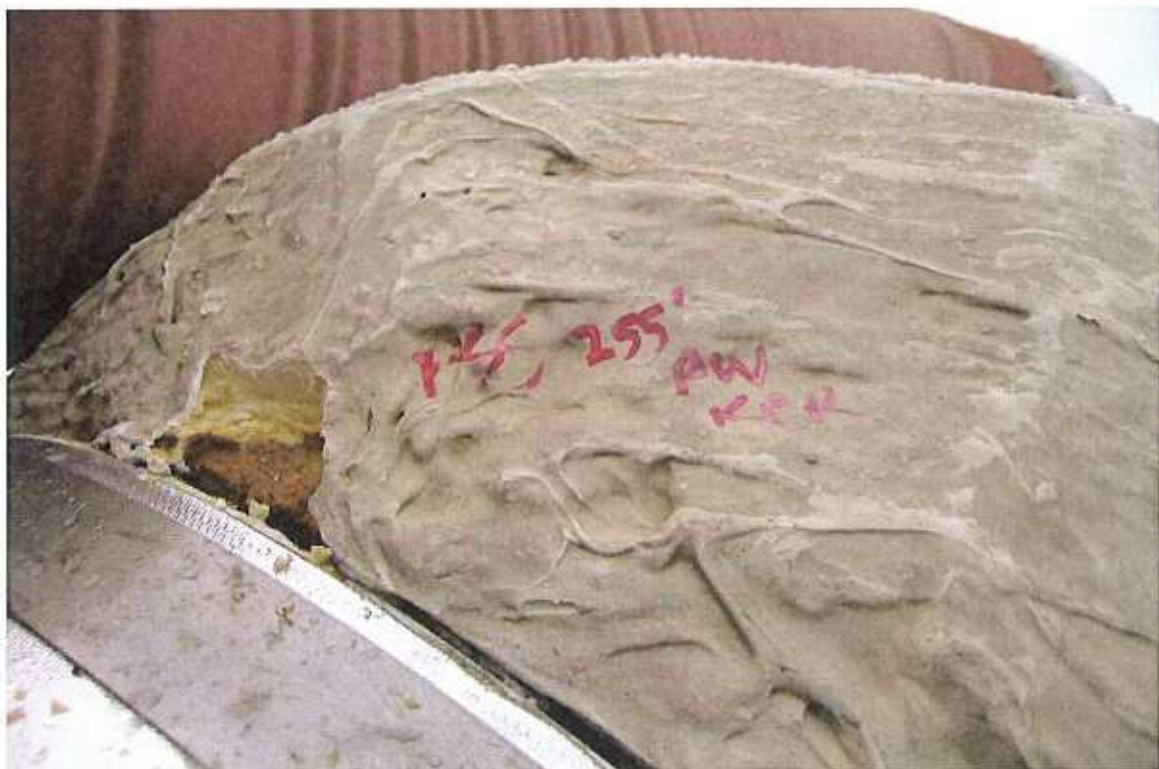
Photo 6 - Foam Insulation on FSS Level 255 – ET Arm

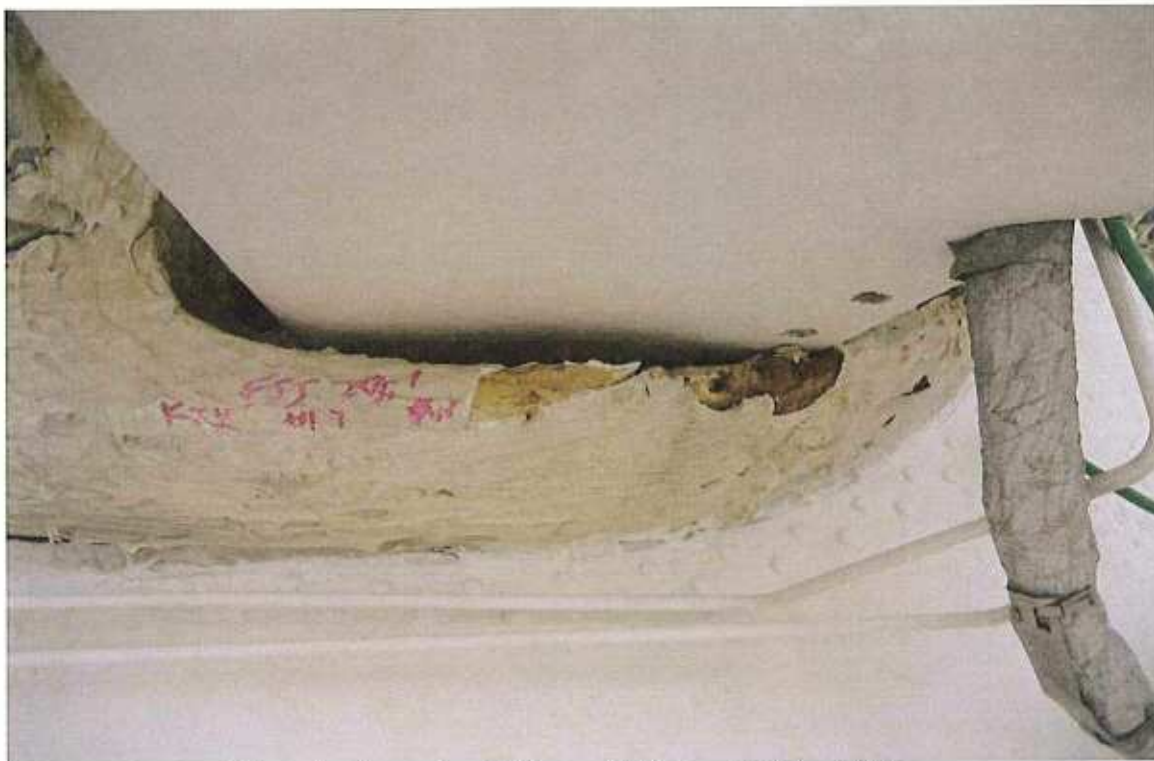
Photo 7 - Foam Insulation on FSS Level 255 – ET Arm

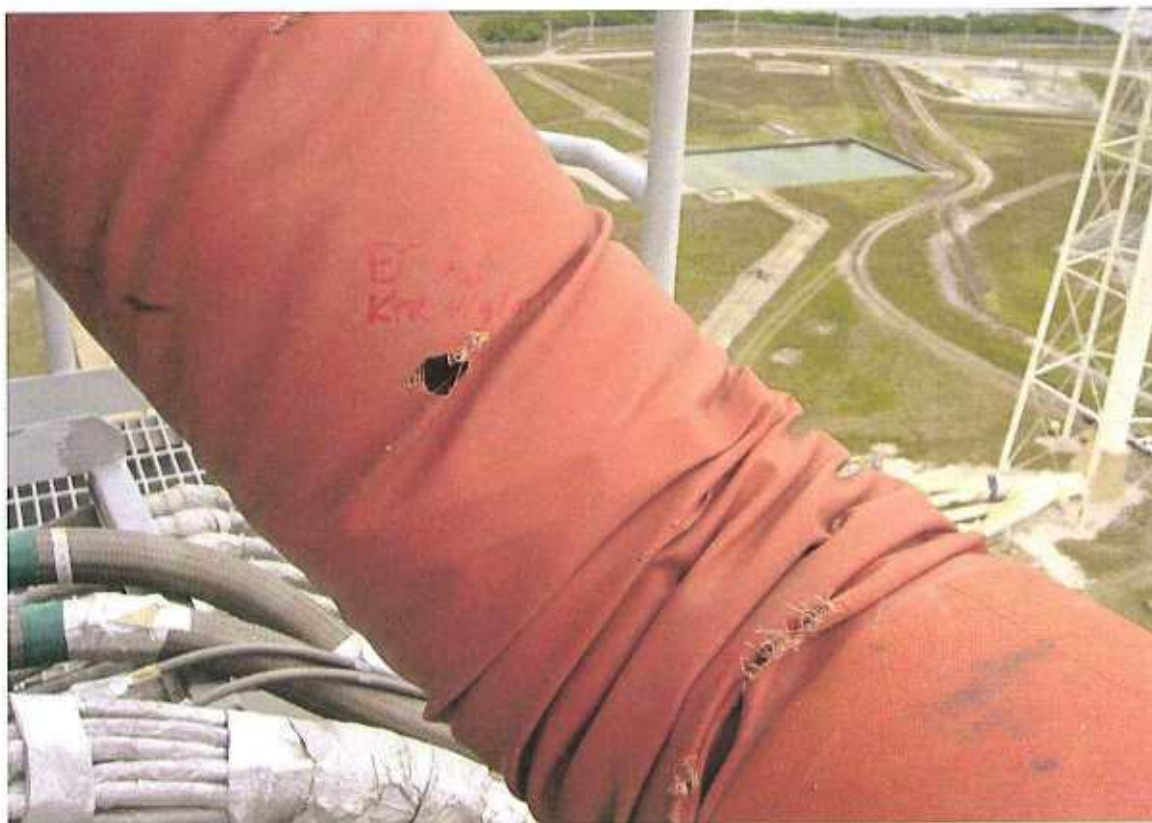
Photo 8 - Pipe Wrap and Insulation on FSS Level 255 – ET Arm

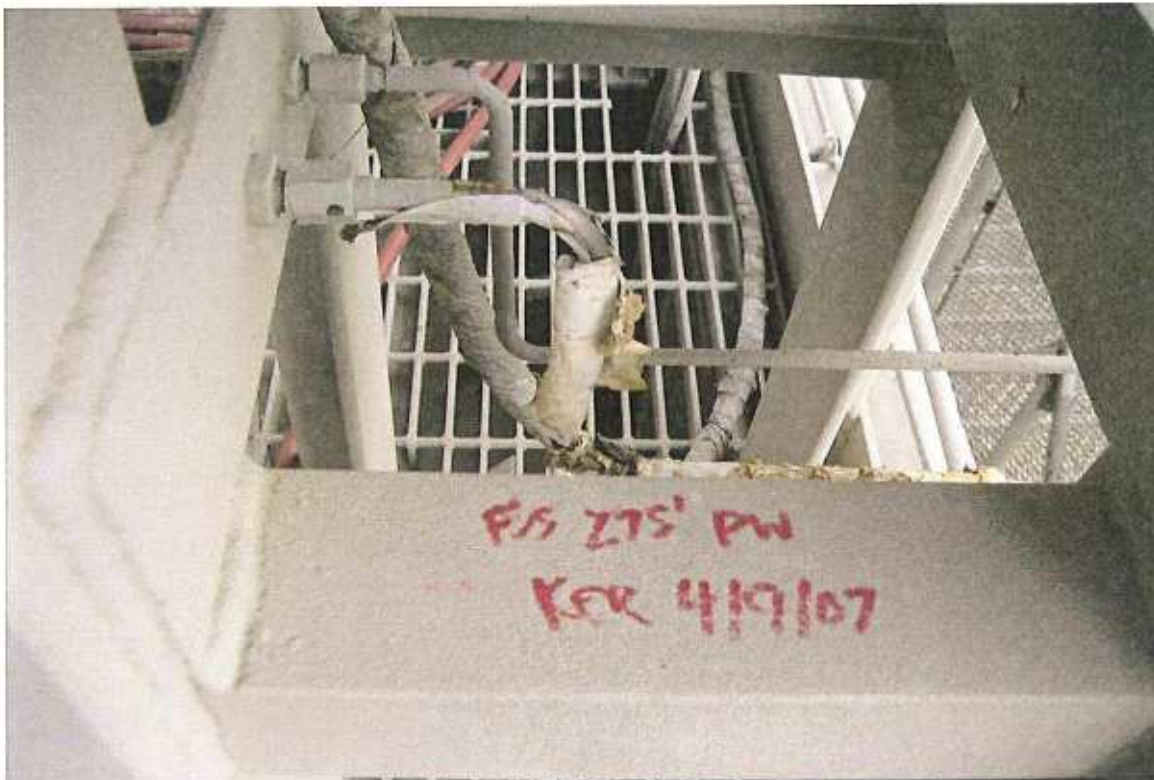
Photo 9 - Electrical Pipe Wrap on FSS Level 275

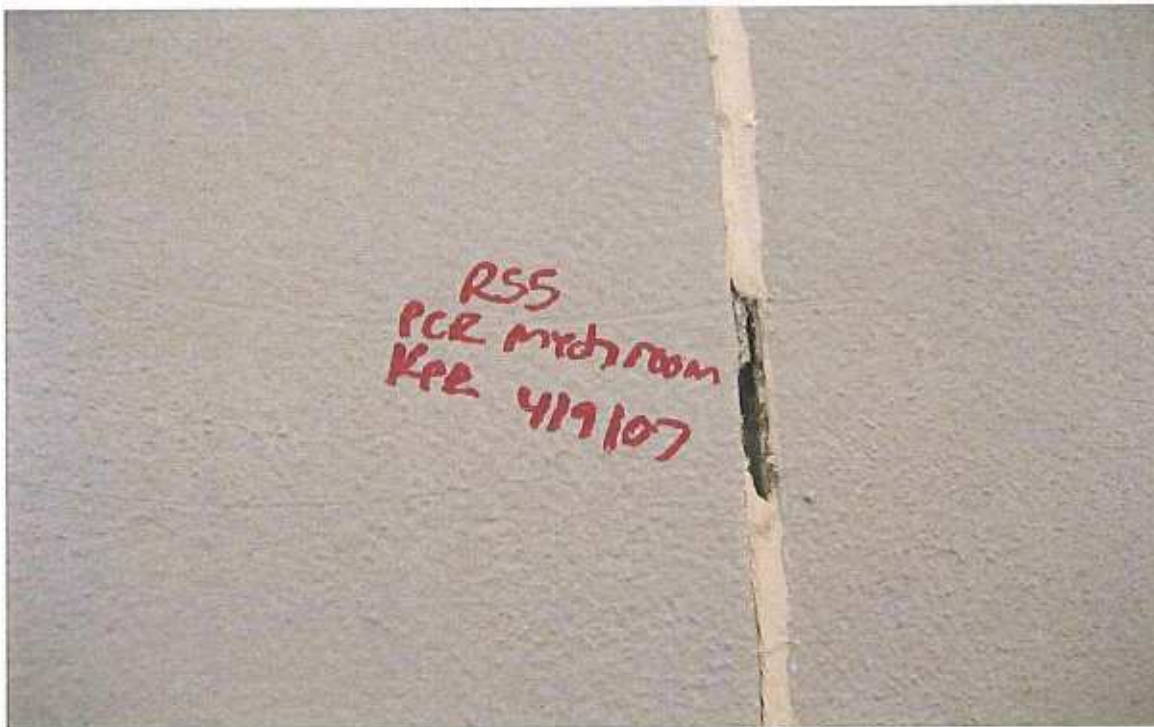
Photo 10 - Caulk at Joints on RSS PCR Mechanical Room

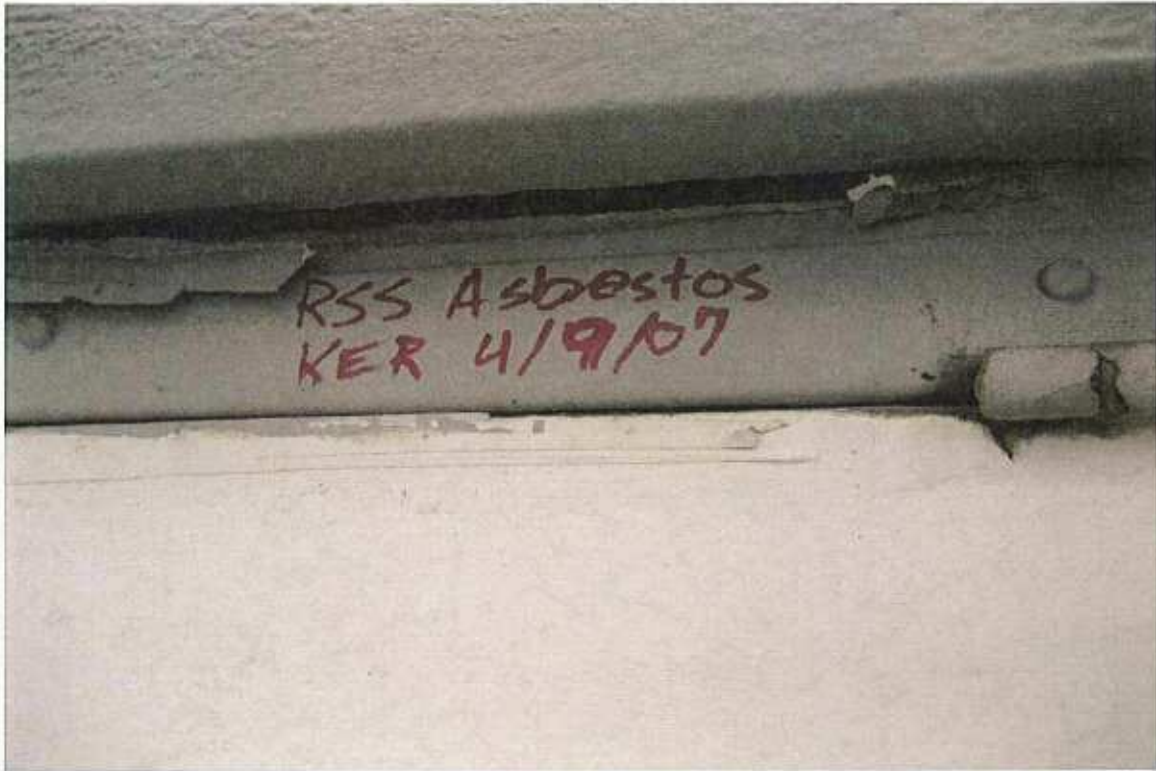
Photo 11 - Caulk at Doors on RSS

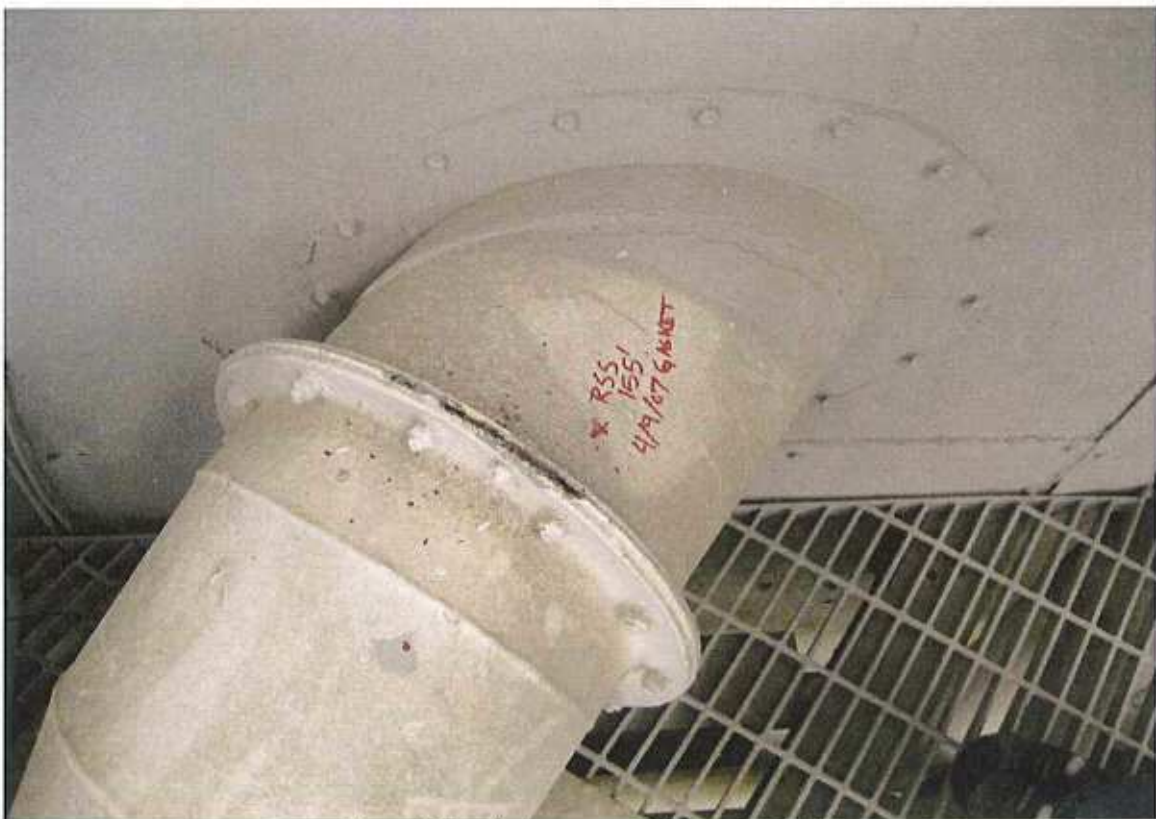
Photo 12 - Gaskets on RSS Level 155

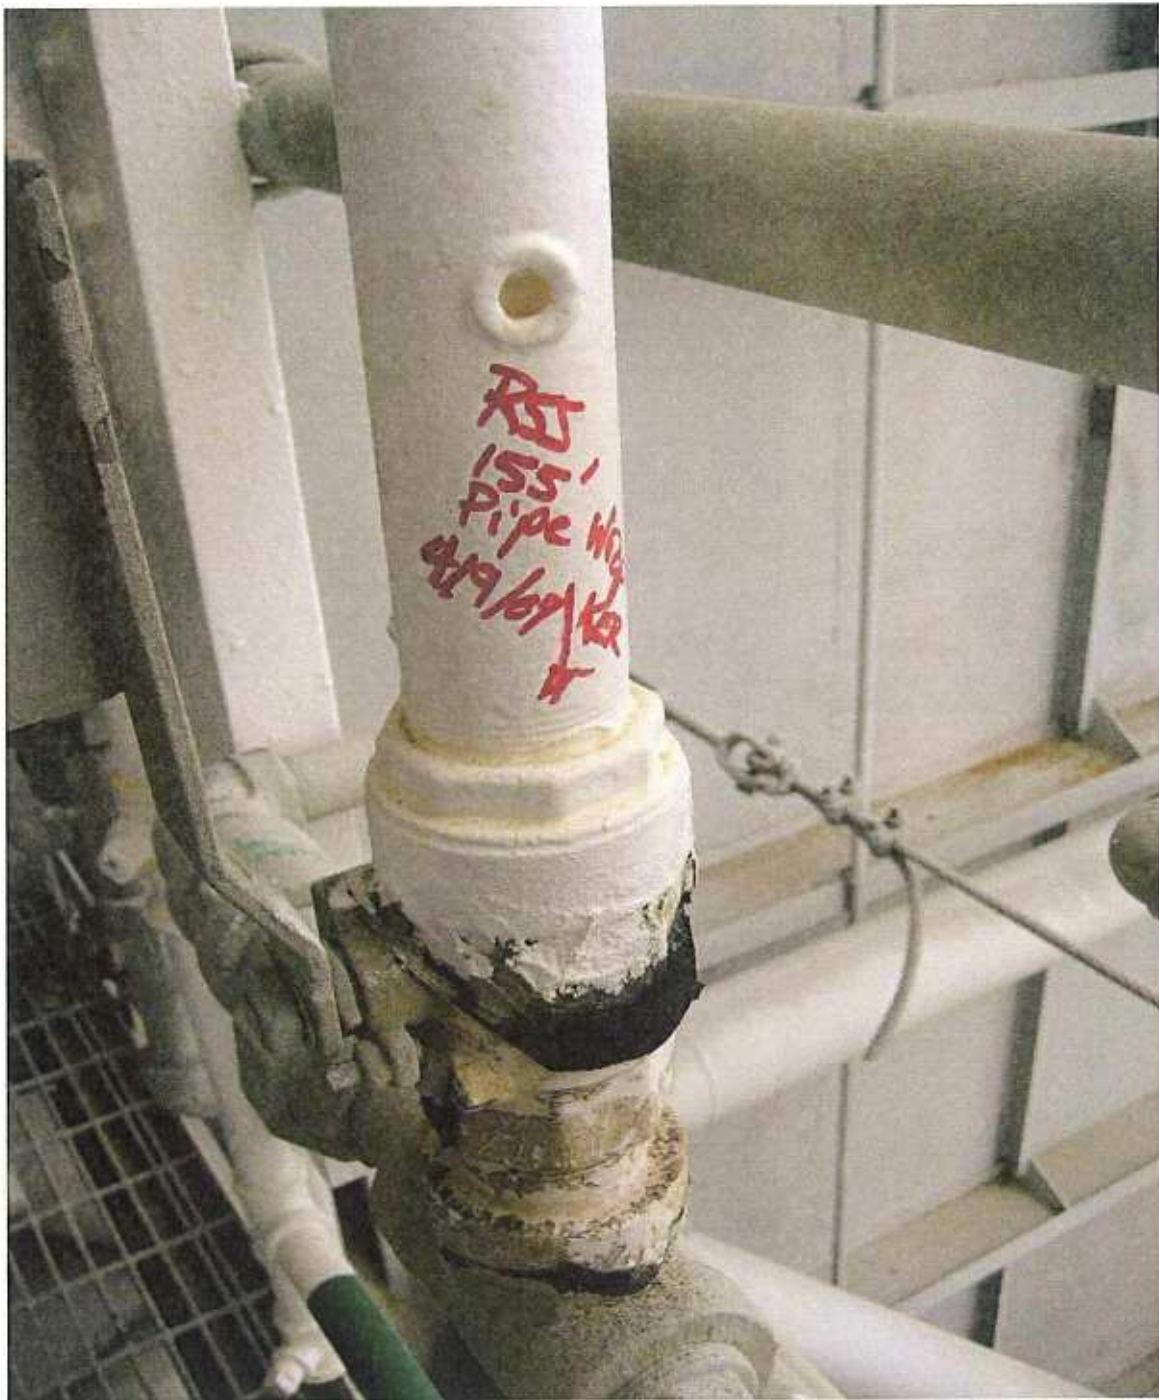
Photo 13 - Pipe Wrap at RSS Level 155

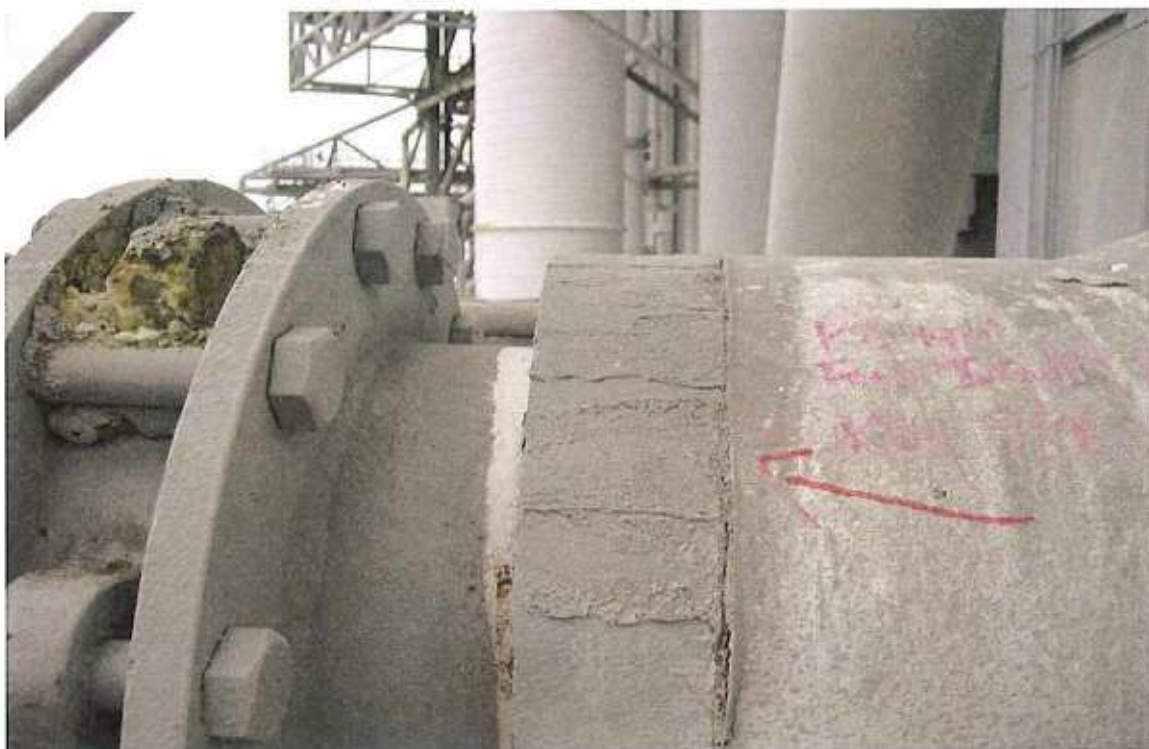
Photo 14 - Foam Insulation at RSS Level 140

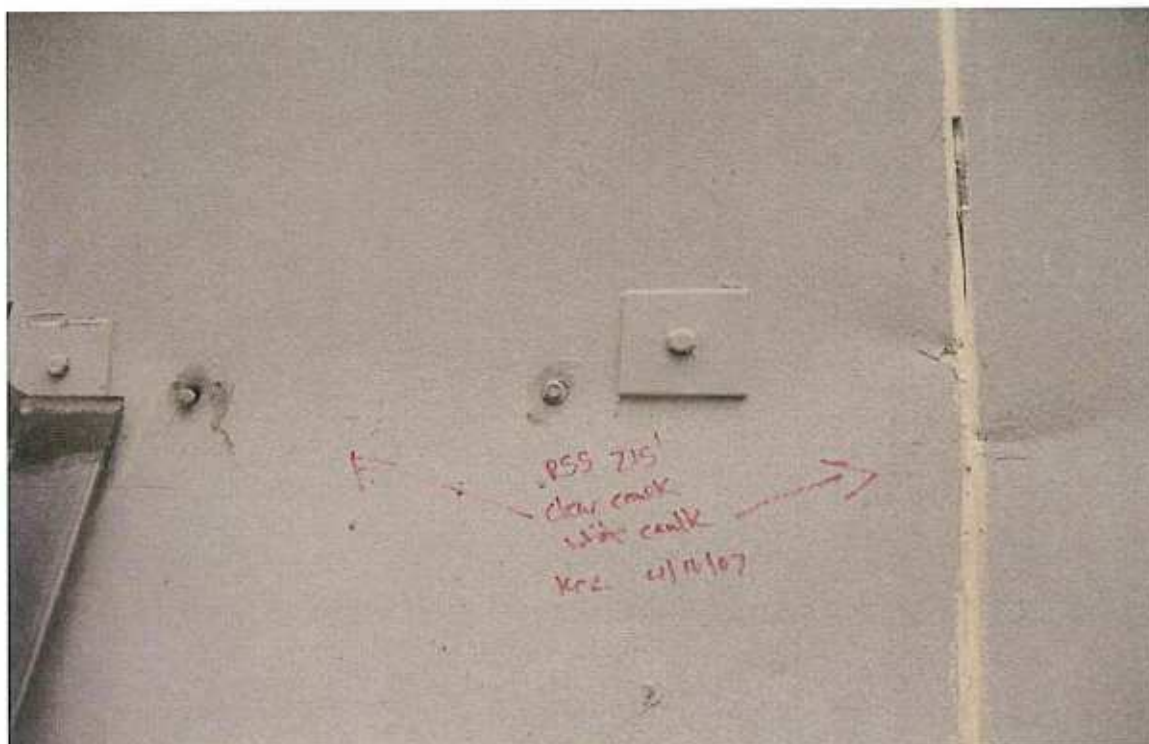
Photo 15 - Caulk on Bolts and Joints on RSS Level 215

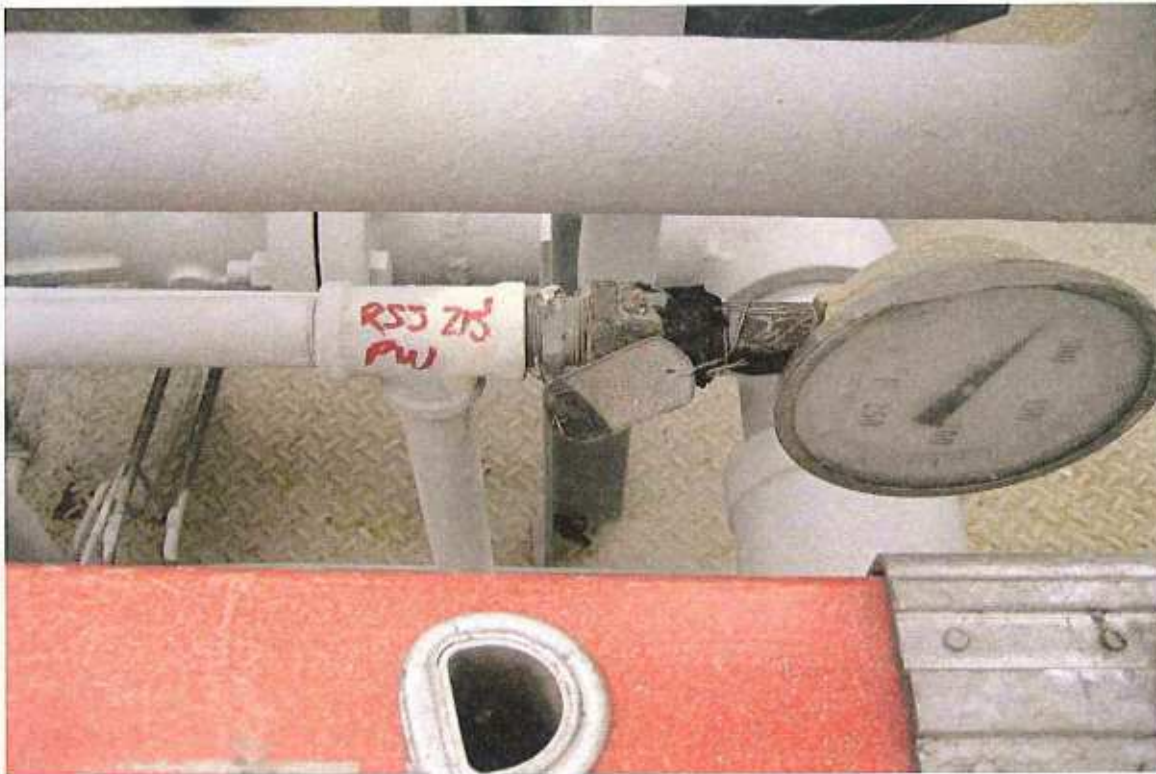
Photo 16 - Pipe Wrap on RSS Level 215

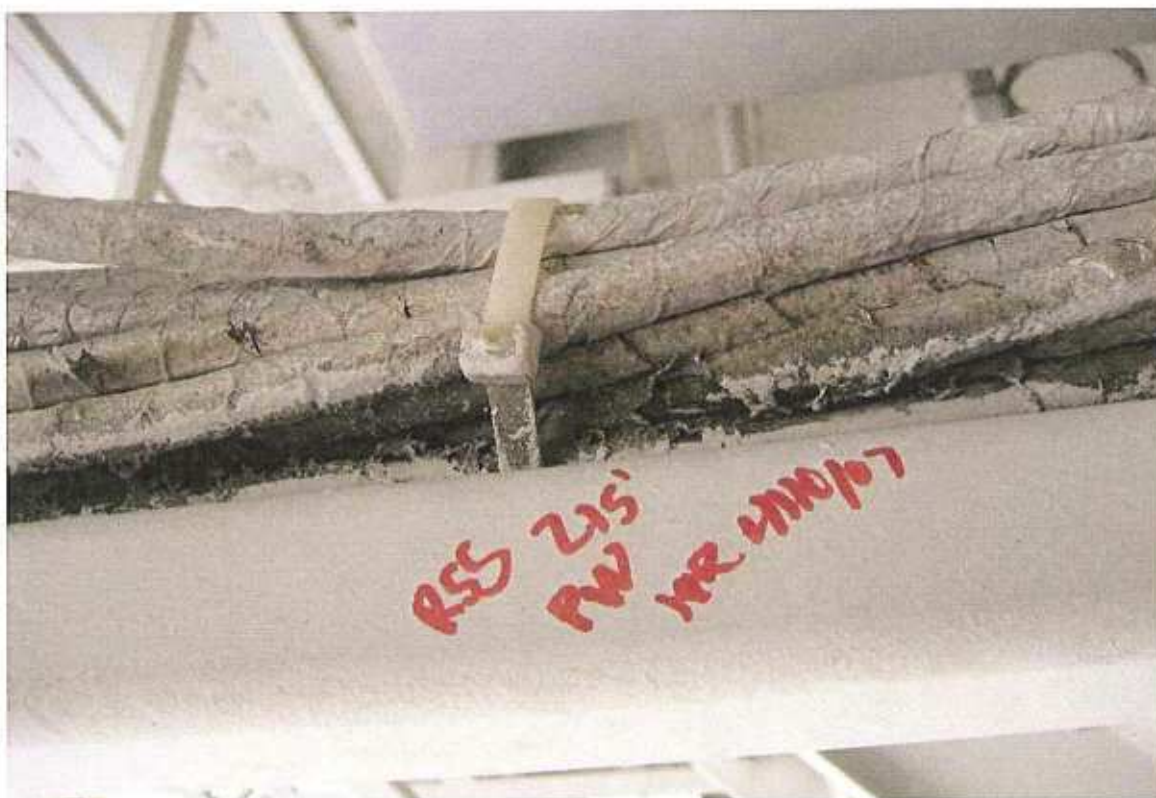
Photo 17 - Electrical Pipe Wrap on RSS Level 215

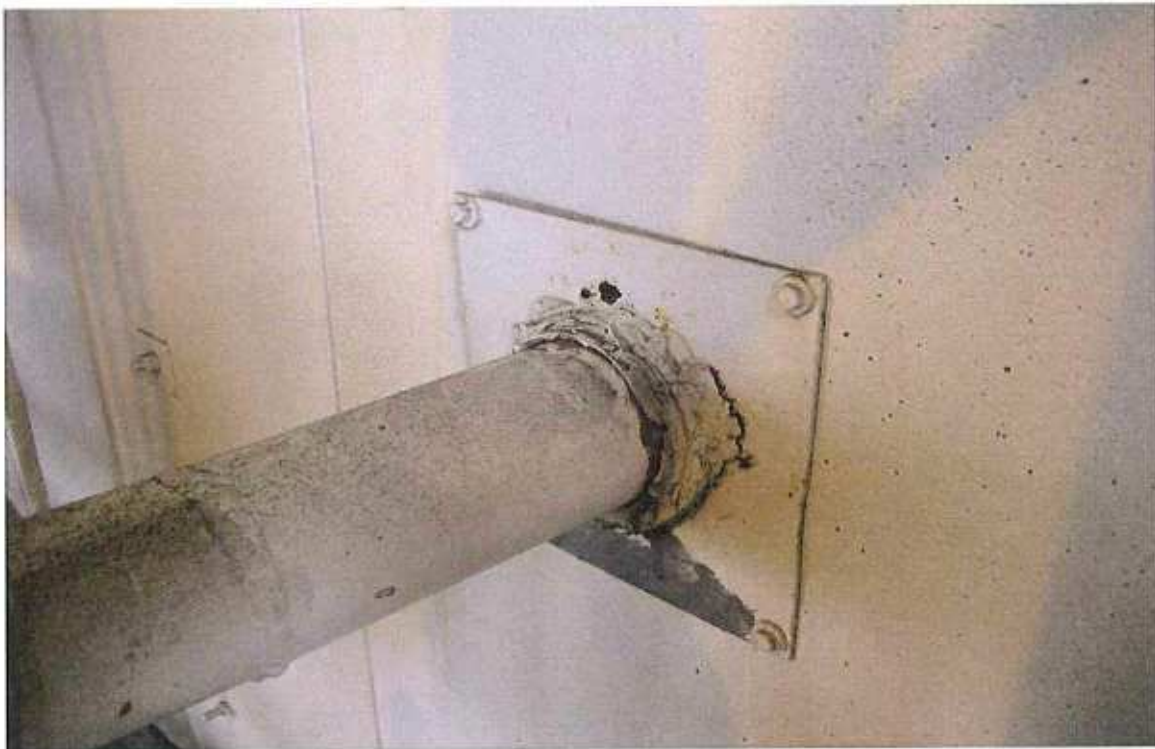
Photo 18 - Pipe Insulation on RSS Level 215

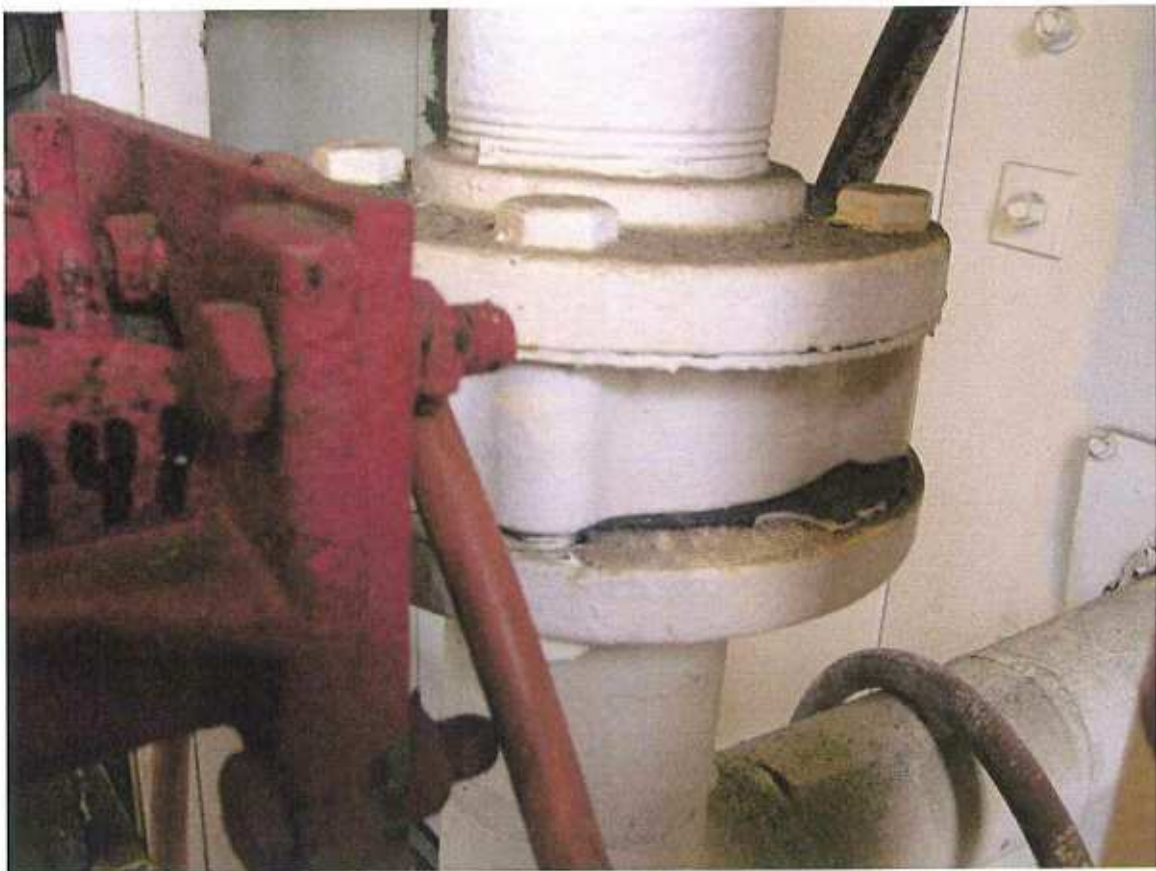
Photo 19 - Gasket on High Pressure Line on RSS PCR\*

\*Materials found to contain Asbestos

All ACM needs to be abated before demolition in accordance with NASA-KSC policy. All waste generated shall be documented using the Process Waste Questionnaire/Technical Response Package (PWQ/ TRP) process as outlined in KNPR 8500.1 and the Contract Clause "Hazardous Waste." Non-friable asbestos will be accepted at the KSC class III landfill upon determination using KSC form 28-1024 and signed by the NASA environmental chief. A receipt of disposal shall be copied to the contracting officer. Disposal of all friable ACM segregated from demolition debris shall be in the Brevard County Landfill located on Adamson road in Cocoa, FL. Category 1 non-friable asbestos that becomes friable by demolition activities or is in poor condition and will become friable shall be treated as friable regulated ACM and shall also be taken to the Brevard County Landfill.

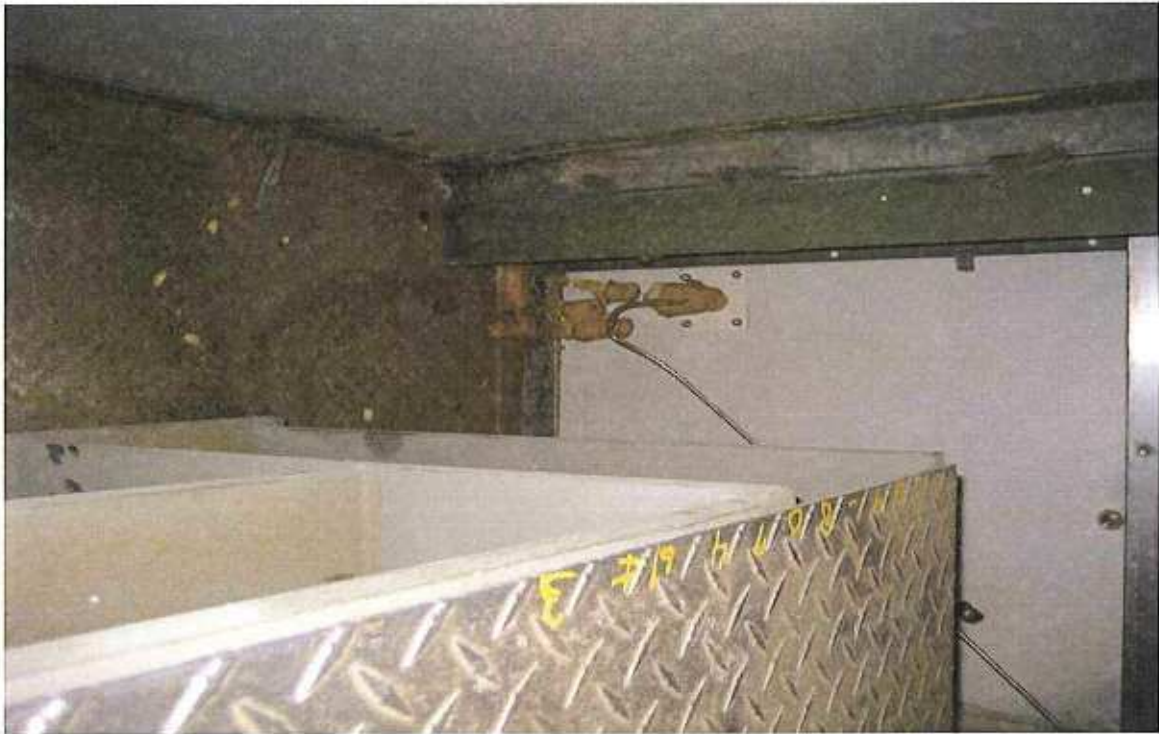
Photo 20 - Foam Insulation on RSS Mechanical Room

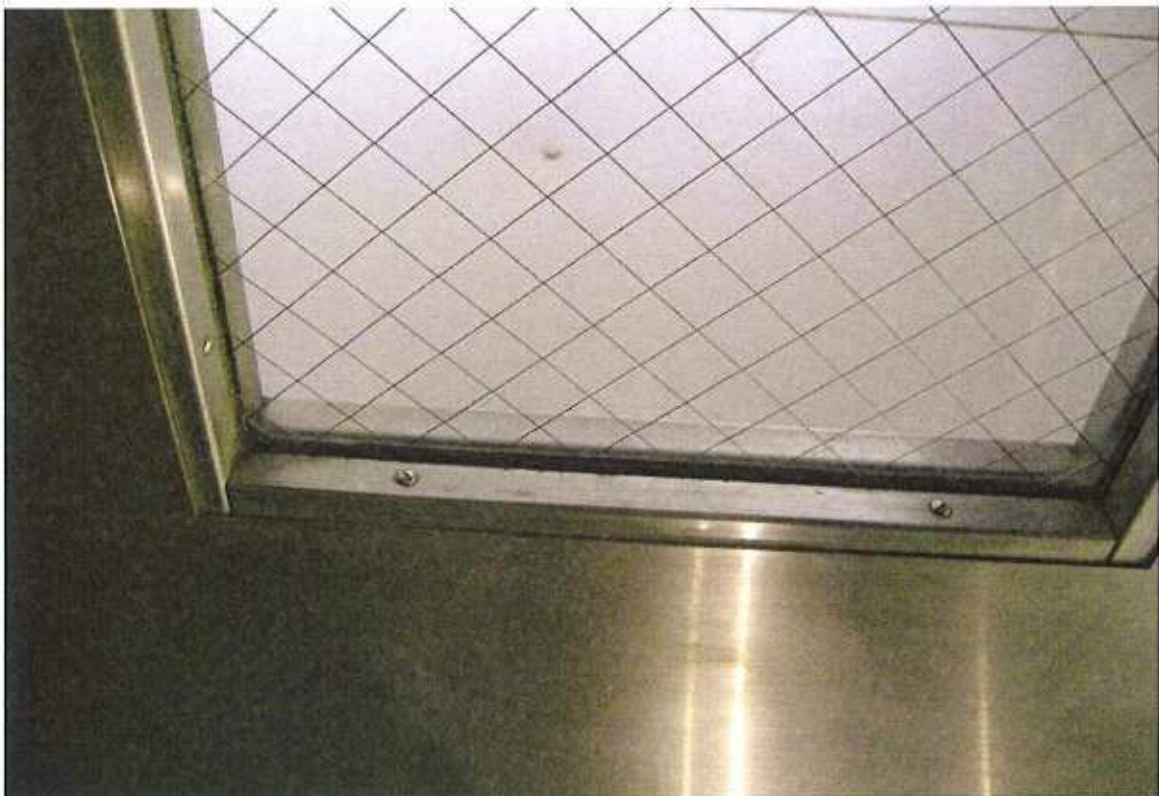
Photo 21 - Caulk on Window at RSS Mechanical Room\*

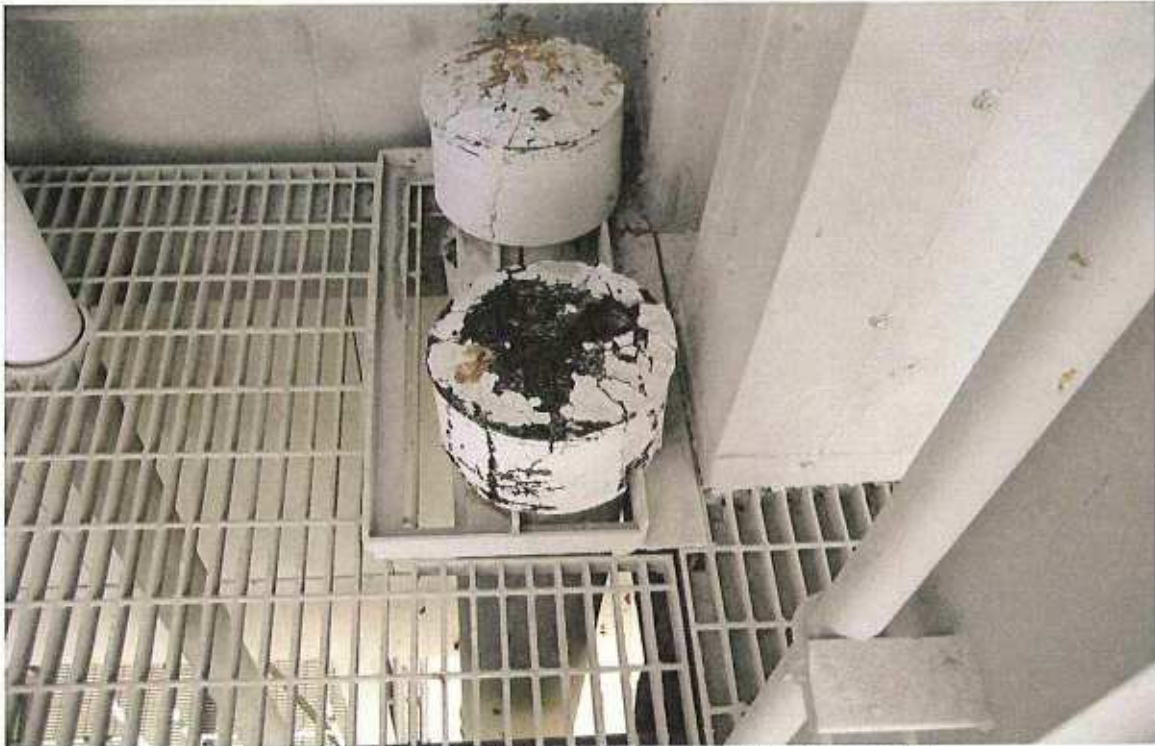
Photo 22 - Pipe Insulation and Foam Insulation at RSS

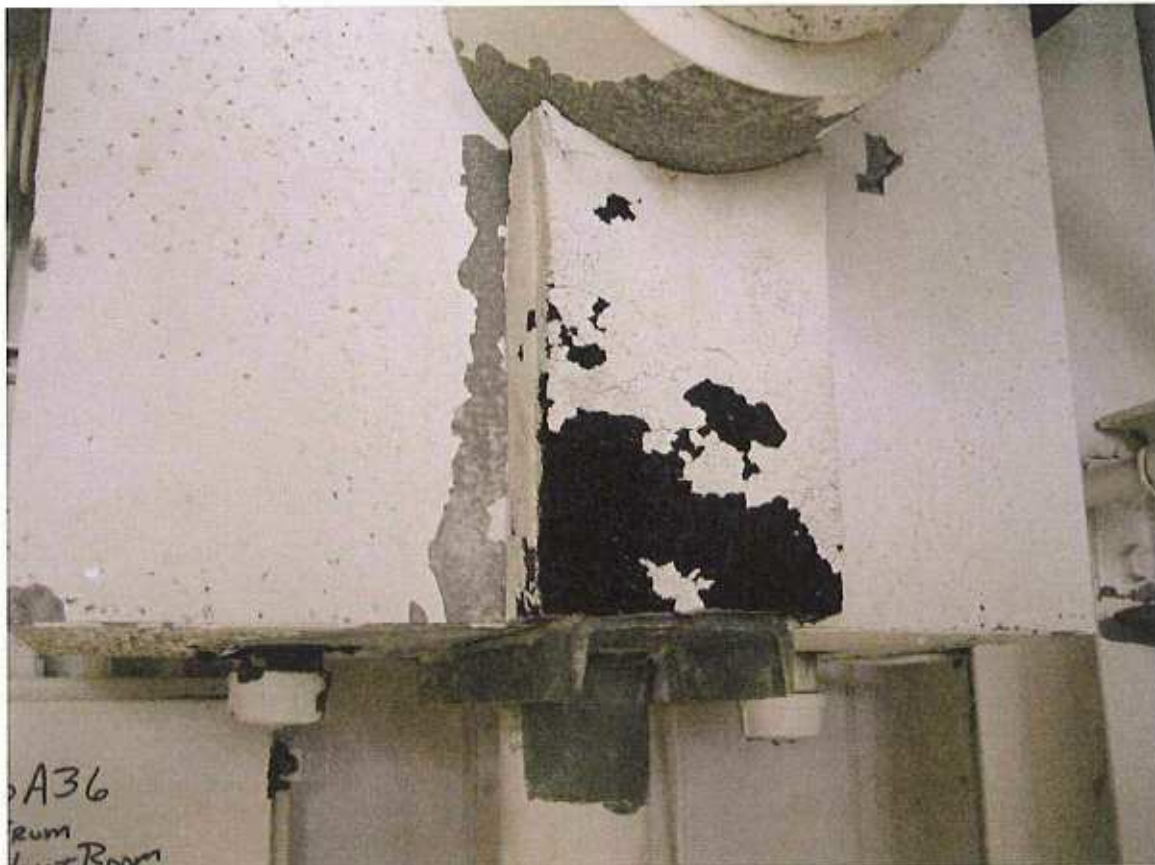
Photo 23 - Pipe Wrap at RSS Patch Room

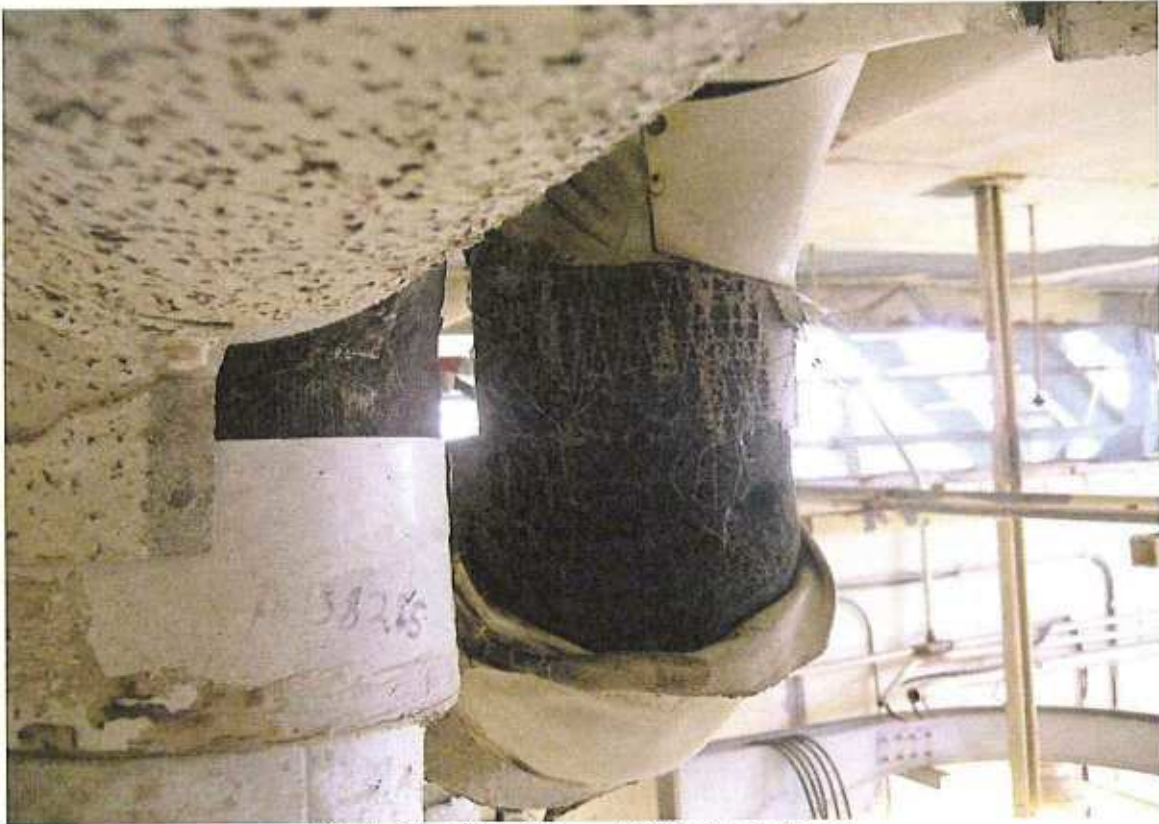
Photo 24 - Pipe Wrap at RSS Patch Room
